SAMPLE RESIDENTIAL PRE-PURCHASE BUILDING REPORT

Complies with Australian Standard AS 4349.1 2007 Property inspections - Part 1 Residential buildings

Re: Structure at: **8 Somewhere St Over There NSW 2000**

Date of the Inspection: 17th Month 2018

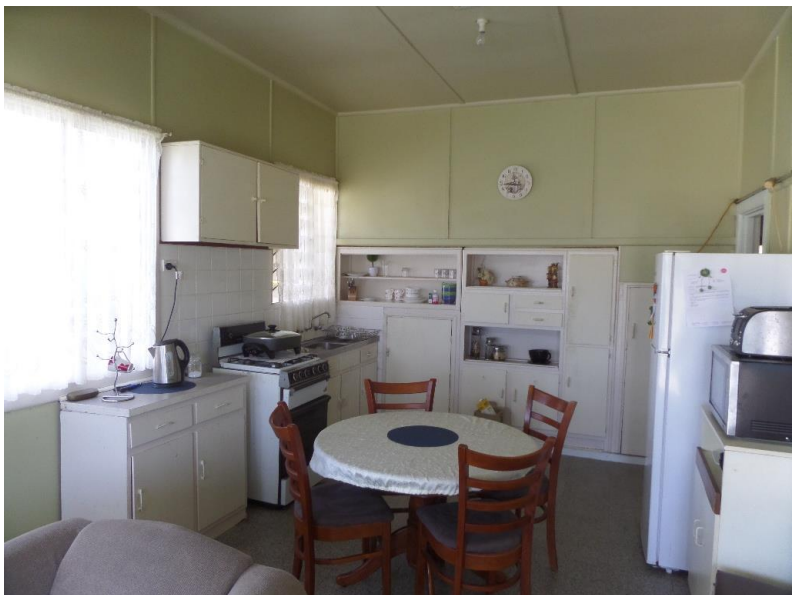
Areas Inspected	Description	General Condition
1.1 Ceilings	Plaster board & exposed timber	Poor
1.2 Walls	Plaster board	Good
1.3 Floors	Timber	Ceramic Tiles throughout except carpeted in bedrooms. Unable to comment
1.4 Floor Coverings	Carpet Ceramic Tiles	Fair Sections are loose and drummy
1.5 Skirtings and Architraves	Timber	Good
1.6 Windows	Aluminium sliding	Good
1.7 Doors and Frames	Timber	Timber frames.
1.8 Kitchen (a) Floor (b) Bench Tops (c) Cupboards (d) Sinks/Taps (d) Tiles	Timber	Covered with ceramic tiles unable to comment
	Laminate	Original Poor
	Timber	Original Poor
	Stainless steel.	Original Poor
	Ceramic	Original Poor
Photo: Kitchen

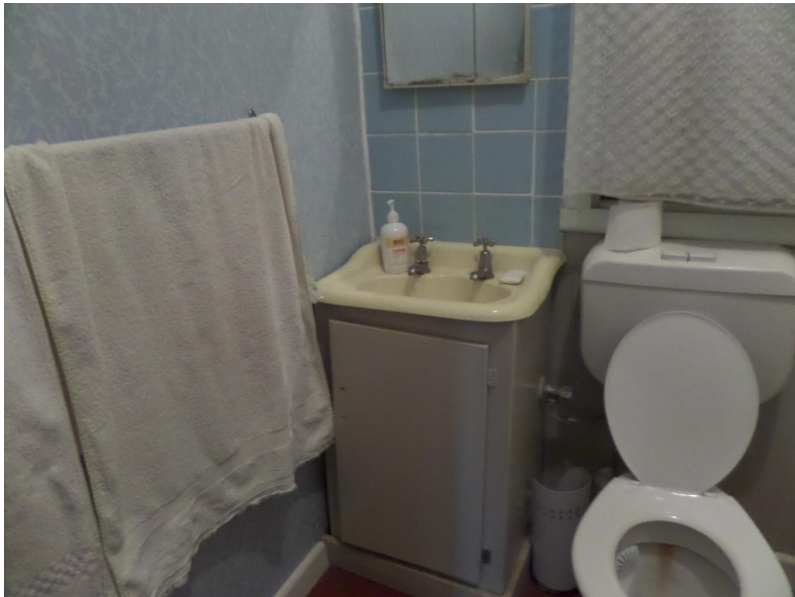
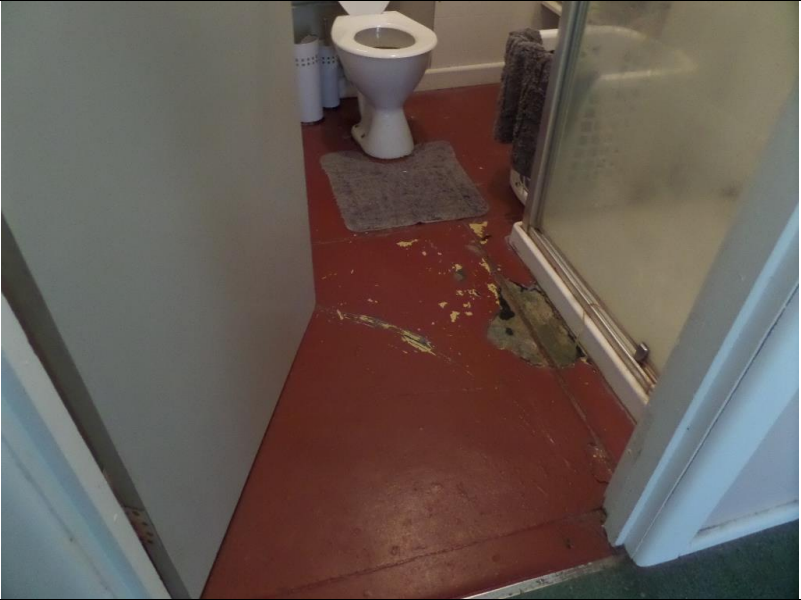
1.9 Bathroom and WC		
(a) Floor	Painted Concrete	Original Poor
(b) Toilet	Ceramic pan & PVC Cistern	Original Poor
(c) Taps	Metal Handles	Original Poor
(d) Tiles	Ceramic floor and partial wall. Majority is lamiboard AC sheeting. No waterproofing	Original Poor
(e) Bath	Nil	
(f) Shower	Separate	Original Poor
(g) Washbasin	Vanity	Original Poor
(h) Ventilation	Nil	
(i) Mirrors	Mirror.	Fixed mirror.
Photo: Bathroom

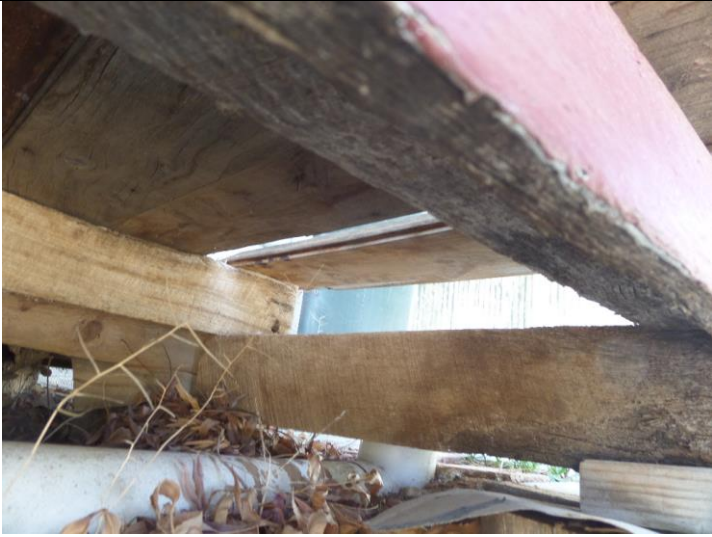
Areas Inspected	Description	General Condition
3.1 Flooring	Strip & Sheet Flooring	Fair
3.2 Bearers and Joists	Timber	Fair
3.3 Piers	Tree stumps	Require restumping & ant capping
3.4 Formwork	Unknown

3.5 Ventilation	Open subfloor	Poor clearance
3.6 Ant Caps and Shielding	missing	
3.7 Damp Course	N/A	
3.8 Drainage		
3.9 Plumbing		VISUAL INSPECTION ONLY *It is recommended to consult a licensed plumber for further advice
Photo: Subfloor

- The dwelling is built on literal tree trunk stumps. No ant capping
- The overall condition of the dwelling is such that it is recommended for demolition.
- The double size block of land on which it sits may well be worth considering for development STCA.
- The cost to renovate would place it beyond economic repair.
